SEISMIC EVALUATION OF COMBINED FABRIC LIMITED (CFL) – ADMIN BLOCK (HR BUILDING)

January 2019

DEPARTMENT OF EARTHQUAKE ENGINEERING
NED UNIVERSITY OF ENGINEERING AND TECHNOLOGY

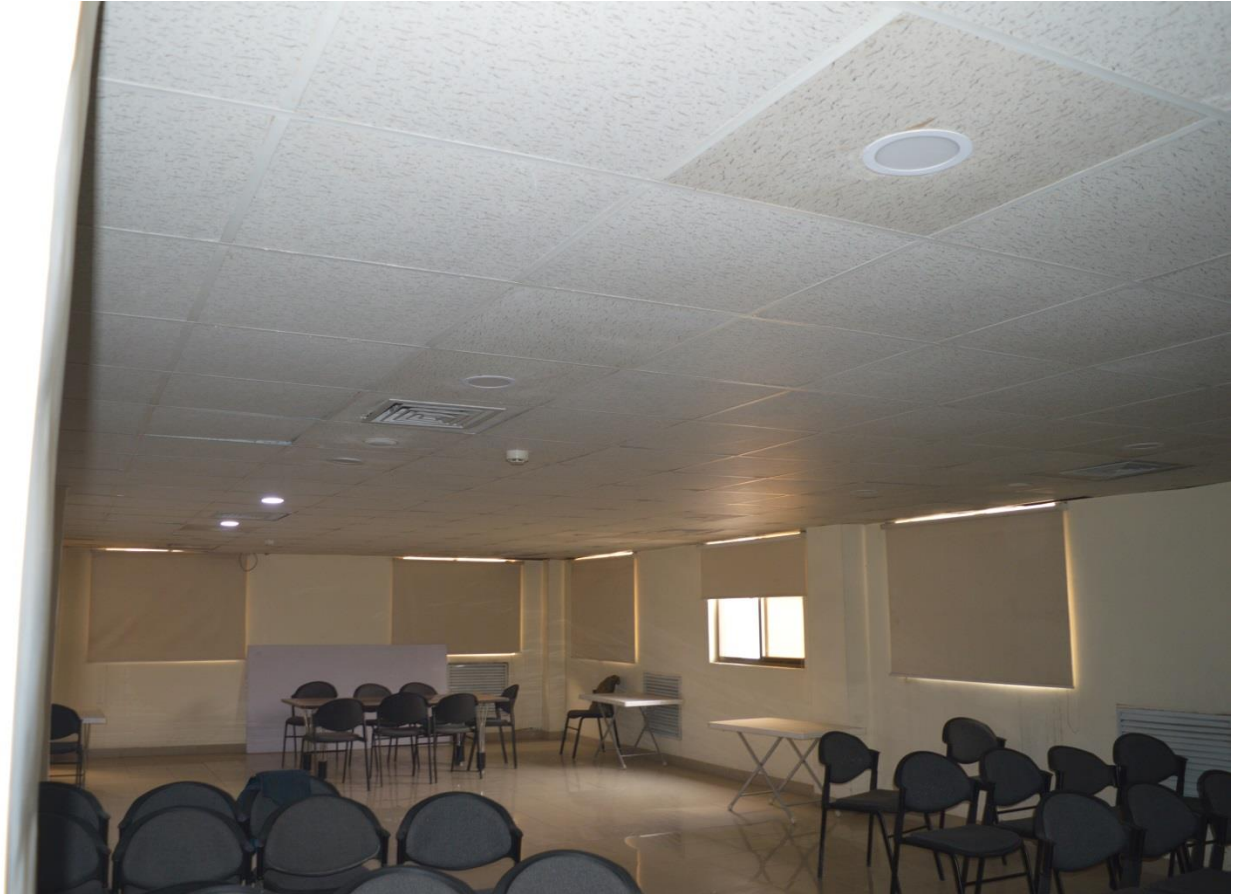
Figure 4: Proper anchorage of cladding and fixtures

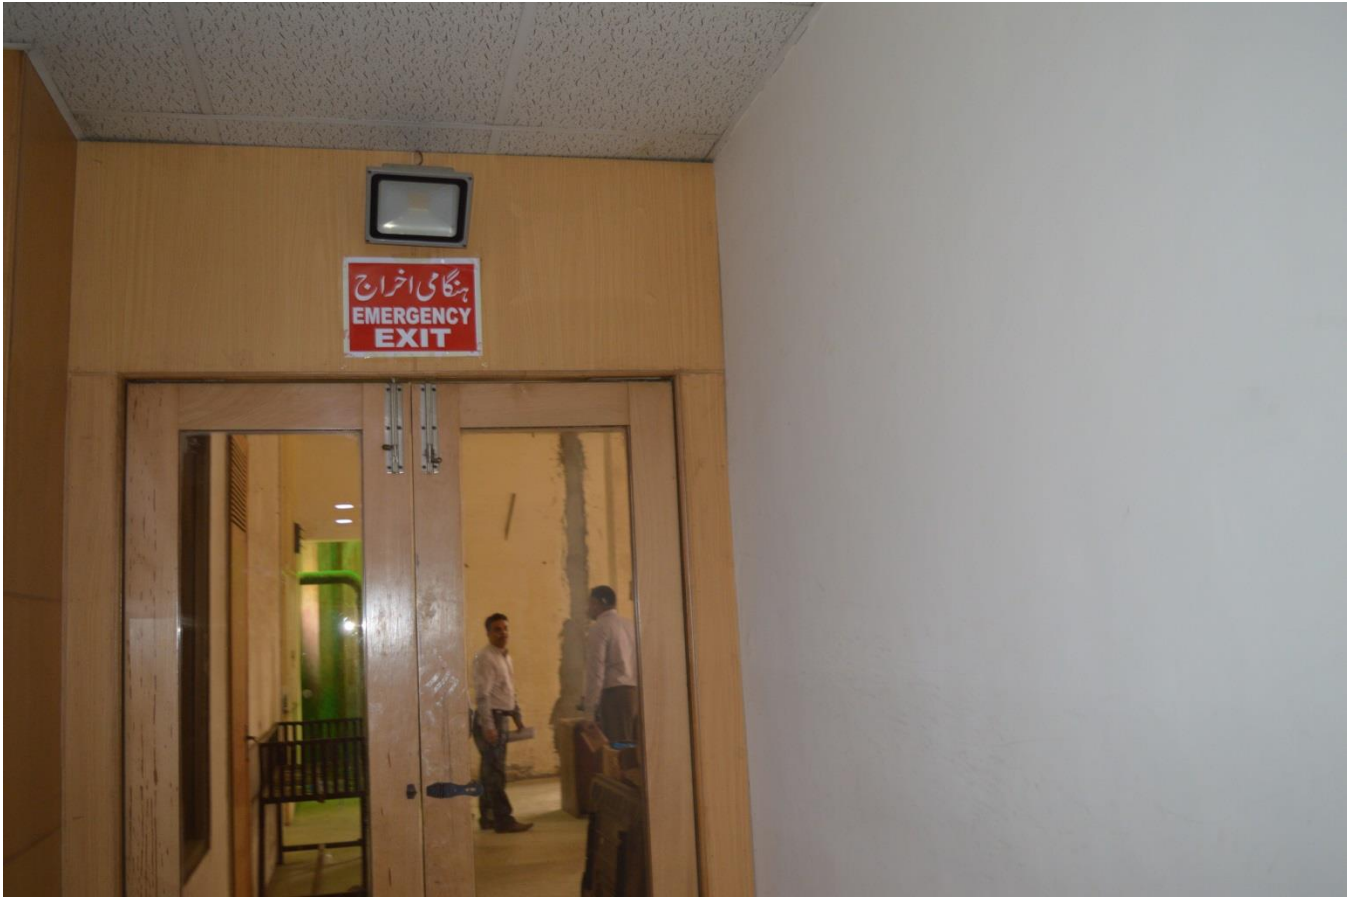
Figure 5: Emergency Exit signs are places appropriately
