# **COMBINED FABRICS LIMITED New Buildings (Extended Area)**

## **Electrical Safety Assessment Report**

**Inspection Date:**  
9<sup>th</sup>-12<sup>th</sup> & 15<sup>th</sup>, 16<sup>th</sup> April, 2019

**BV Job No. PAK-BV-40-19-0131-LHR**

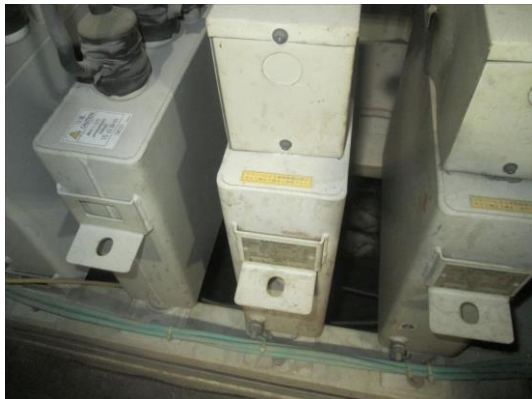
**1. LT Room – Electrical Panel No. 02 ( PFI )**

| BV Observation | | |
|---|---|---|
| <ul style="list-style-type: none"> <li>Bottom side panel sheet missing.</li> </ul> | <ul style="list-style-type: none"> <li>Panel shall be closed / sealed from all the side to prohibit dust / vermin entry into the panel. This action applies to all locations with similar observations.</li> </ul> | |

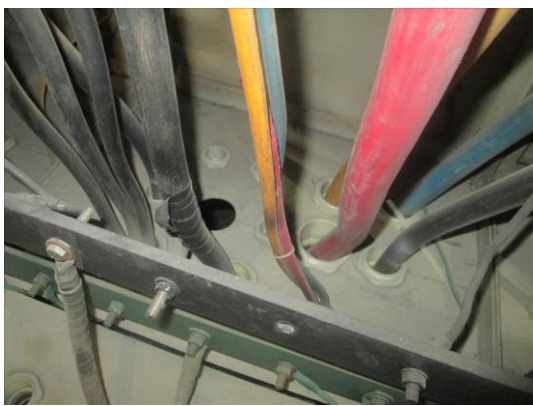
| BV Observation | | |
|---|---|---|
| <ul style="list-style-type: none"> <li>Open hole observed on the bottom side of the panel &amp; loose glands used.</li> </ul> | <ul style="list-style-type: none"> <li>Panel shall be closed / sealed from all the side to prohibit dust / vermin entry into the panel &amp; glands of appropriate size shall be provided at the cable's entry / exit points of cables into the panel.</li> </ul> | |

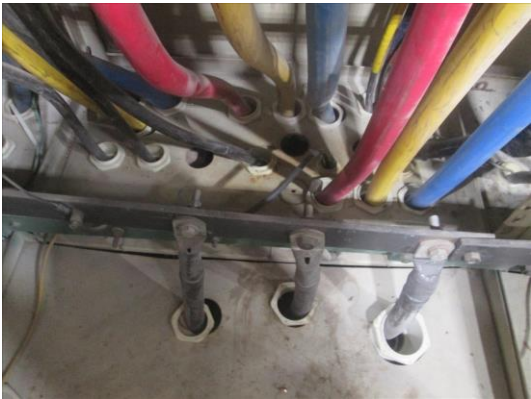
| BV Observation | | |
|---|---|---|
| <ul style="list-style-type: none"> <li>Open hole observed on the bottom side of the panel &amp; loose glands used.</li> </ul> | <ul style="list-style-type: none"> <li>Panel shall be closed / sealed from all the side to prohibit dust / vermin entry into the panel &amp; glands of appropriate size shall be provided at the cable's entry / exit points of cables into the panel size's.</li> </ul> | |

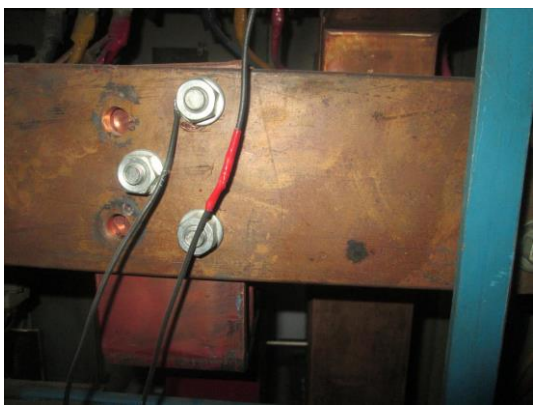
**4. LT Room – Electrical Panel No. 06 ( Diesel Generator – 3516 )**

| BV Observation | | |
|---|---|---|
| <ul style="list-style-type: none"> <li>Termination on bus bar without lugs, standard color of bus bars for three phase's indication not followed &amp; spliced joint observed.</li> </ul> | <ul style="list-style-type: none"> <li>Standard colored bus bars (Red/Yellow/Blue) for three phase's indication shall be followed, lugs shall be used for all terminations &amp; spliced joints shall be removed.</li> </ul> | |

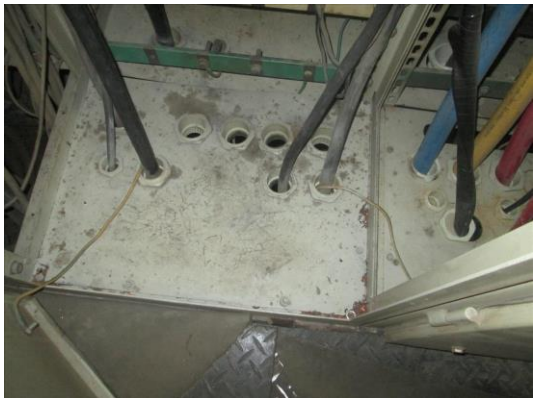
| BV Observation | | |
|---|---|---|
| <ul style="list-style-type: none"> <li>Open holes observed on the bottom side of the panel &amp; loose glands used.</li> </ul> | <ul style="list-style-type: none"> <li>Panel shall be closed / sealed from all the side to prohibit dust / vermin entry into the panel &amp; glands of appropriate size shall be provided at the cable's entry / exit points of cables into the panel size's.</li> </ul> | |

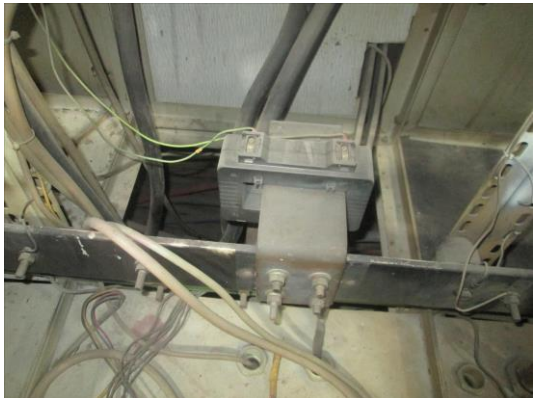
| BV Observation | | |
|---|---|---|
| <ul style="list-style-type: none"> <li>Bottom side panel sheet missing &amp; open holes observed.</li> </ul> | <ul style="list-style-type: none"> <li>Panel shall be closed / sealed from all the side to prohibit dust / vermin entry into the panel. This action applies to all locations with similar observations.</li> </ul> | |

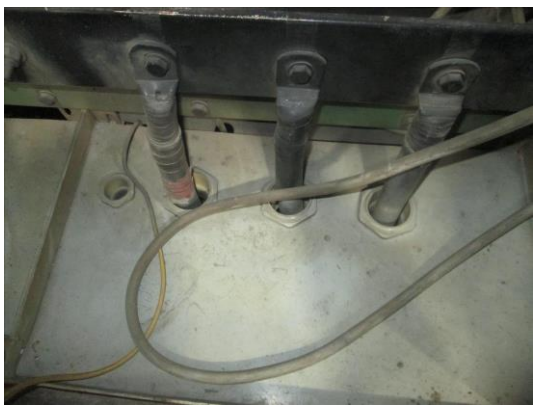
| BV Observation | | |
|---|---|---|
| <ul style="list-style-type: none"> <li>Open holes observed on the bottom side of the panel &amp; loose glands used.</li> </ul> | <ul style="list-style-type: none"> <li>Opening of all type inside the panel shall be removed &amp; glands of appropriate size shall be provided at the cable's entry / exit points of cables into the panel size's.</li> </ul> | |

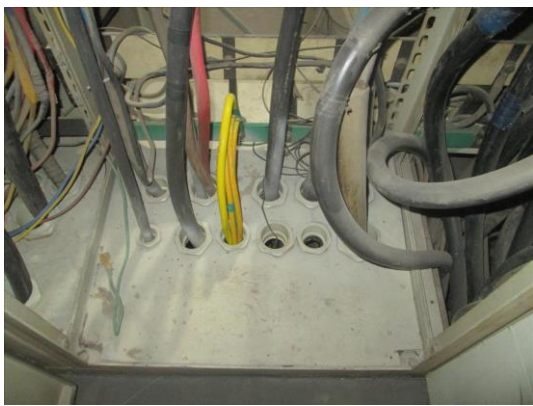
**7. LT Room – Electrical Panel No. 10 ( Outgoing )**

| BV Observation | | |
|---|---|---|
| <ul style="list-style-type: none"> <li>Electrical panel has an opening from the bottom side. This opening allows vermin &amp; moisture to enter inside the electrical panel.</li> </ul> | <ul style="list-style-type: none"> <li>All electrical panels should be properly sealed. Proper sealing of panels helps in protecting panels from short circuiting due to vermin.</li> </ul> | |

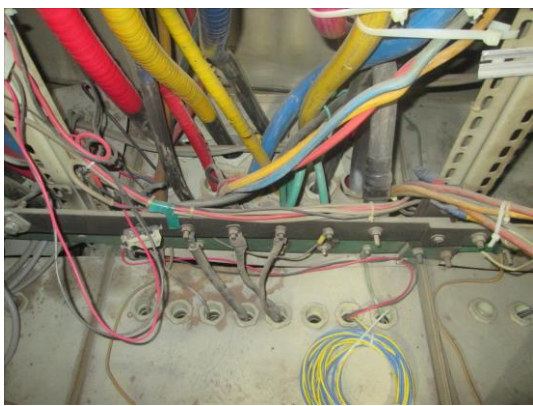
| BV Observation | | |
|---|---|---|
| <ul style="list-style-type: none"> <li>Electrical panel has an opening from the bottom side. This opening allows vermin &amp; moisture to enter inside the electrical panel.</li> </ul> | <ul style="list-style-type: none"> <li>All electrical panels should be properly sealed. Proper sealing of panels helps in protecting panels from short circuiting due to vermin.</li> </ul> | |

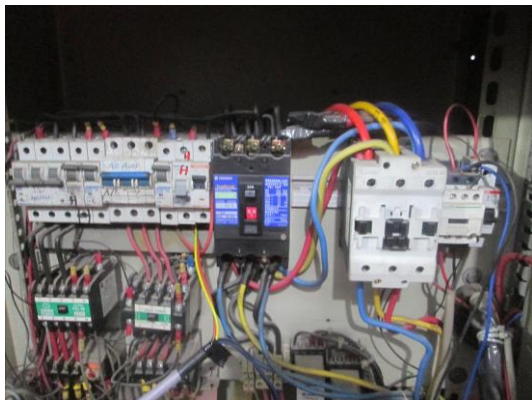
**9. MDB – Power House**

| BV Observation | | |
|---|---|---|
| <ul style="list-style-type: none"> <li>Phase separators of MCCBs are missing &amp; looping from inside observed.</li> </ul> | <ul style="list-style-type: none"> <li>Phase separators of MCCBs shall be provided &amp; looping shall be removed.</li> </ul> | |

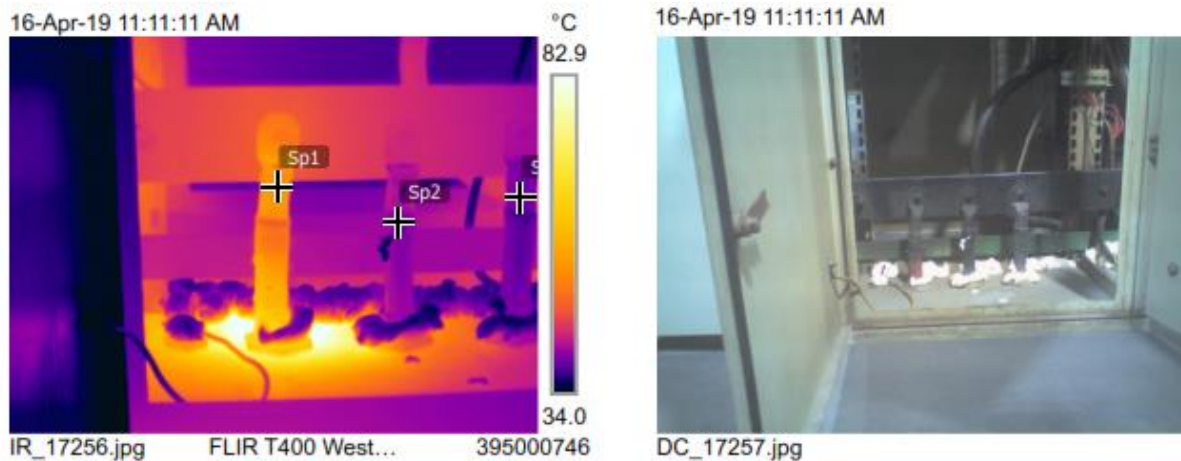
**Equipment ID or Name: LT Room – Bus Coupler**

| Sr. NO | ELECTRICAL PANEL NAME | LOCATION | REMARKS | RELATED THERMOGRAM S | THERMOGRAMS REFERENCE PAGE | OBSERVATION |
|---|---|---|---|---|---|---|
| 02 | Bus Coupler P-08 | LT Room | Medium Grade (17256) | 17256 | 04 | Medium grade temperature raise found at thermogram (17256) & Page-04. |

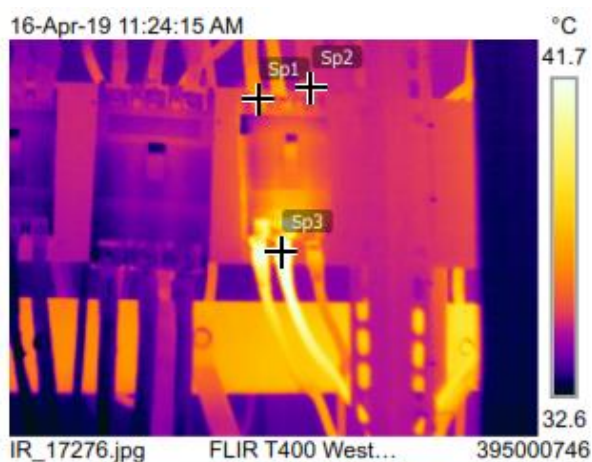
**Equipment ID or Name: LT Room – Electrical Panel # 03 (Outgoing)**

| Sr. NO | ELECTRICAL PANEL NAME | LOCATION | REMARKS | RELATED THERMOGRAM S | THERMOGRAMS REFERENCE PAGE | OBSERVATION |
|---|---|---|---|---|---|---|
| 03 | Outgoing P-03 | LT Room | Low Grade (17276) | 17274<br>17276 | 05,06 | Low grade temperature raise found at thermogram (17276) & Page-06. |

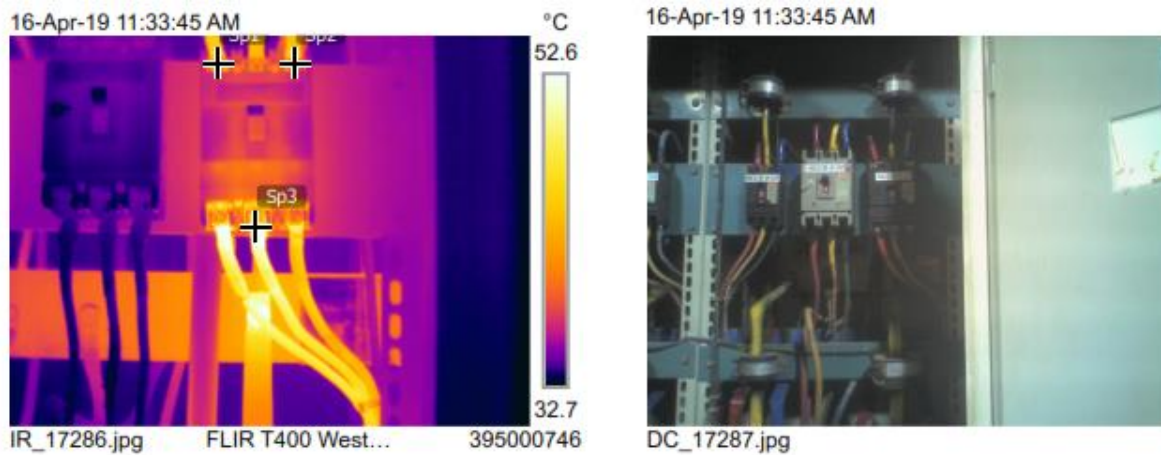
**Equipment ID or Name: LT Room – Electrical Panel # 04 (Outgoing)**

| Sr. NO | ELECTRICAL PANEL NAME | LOCATION | REMARKS | RELATED THERMOGRAM S | THERMOGRAMS REFERENCE PAGE | OBSERVATION |
|---|---|---|---|---|---|---|
| 04 | Outgoing P-04 | LT Room | Medium Grade (17286) | 17286<br>17290<br>17294 | 07,08,09 | Medium grade temperature raise found at thermogram (17286) & Page-07. |
