SEISMIC EVALUATION OF COMBINED FABRIC LIMITED (CFL) – ADMIN BLOCK (HR BUILDING)

January 2019

DEPARTMENT OF EARTHQUAKE ENGINEERING
NED UNIVERSITY OF ENGINEERING AND TECHNOLOGY

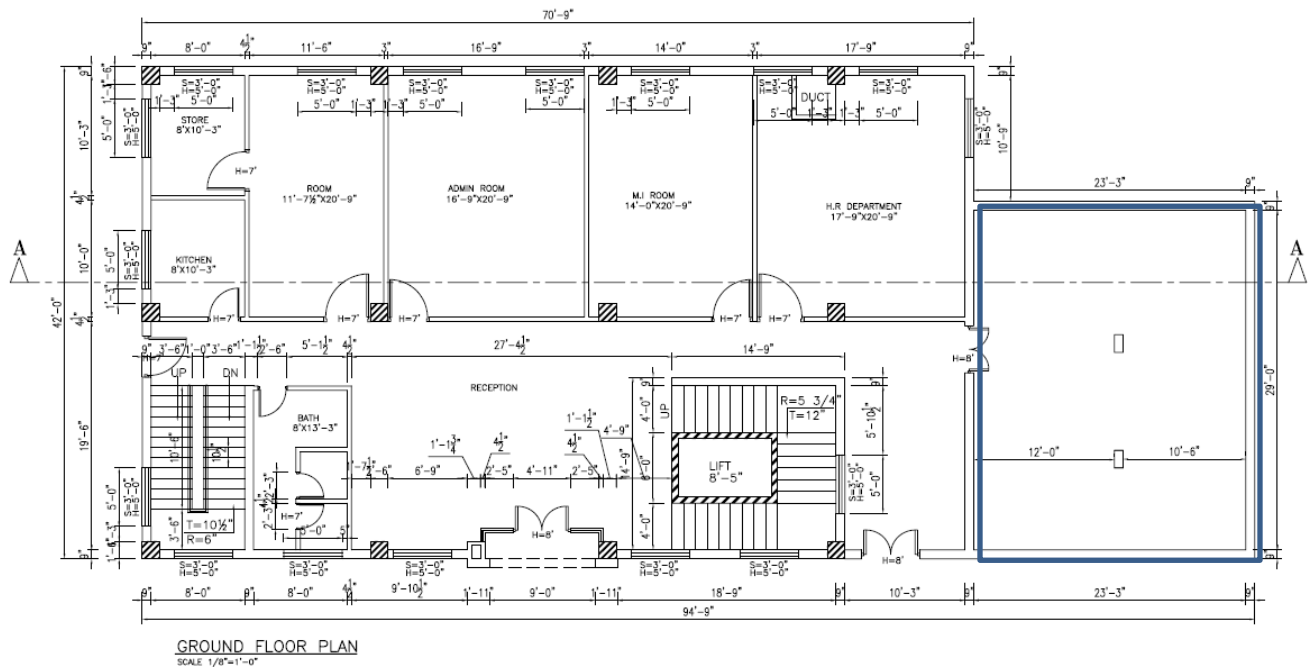
The building has ground plus two stories with exterior rectangular dimensions of 94'-0" wide by 40'-6" long (Figure 1). The total height of the building is (33') with 11 feet height for each storey. The structural system of the building mainly consists of Reinforced Concrete Frame with small part of the building comprising of unreinforced load bearing masonry walls. Stairs are present at two side of the building. One lift is present as well. The isolated footings and combined footings are provided as the foundation. The design compressive strength of concrete is 3 ksi for beams and 3.5 ksi for columns and the yield strength of steel of 60 ksi is used.

Figure 1: Architectural Plan of CFL Admin Block Ground Floor (Highlighted Part is showing URM)
