# **COMBINED FABRICS LIMITED New Buildings (Extended Area)**

## **Electrical Safety Assessment Report**

**Inspection Date:**  
9<sup>th</sup>-12<sup>th</sup> & 15<sup>th</sup>, 16<sup>th</sup> April, 2019

**BV Job No. PAK-BV-40-19-0131-LHR**

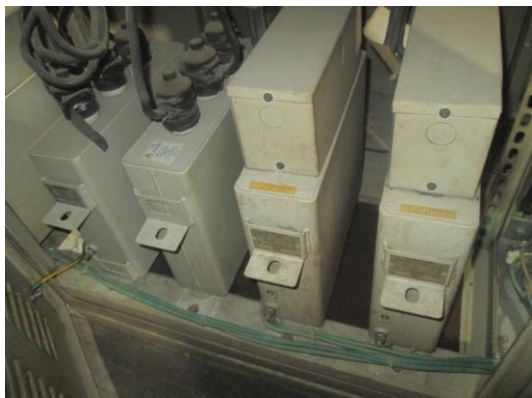
**1. LT Room – Electrical Panel No. 02 ( PFI )**

| BV Observation | | |
|---|---|---|
| <ul style="list-style-type: none"> <li>Bottom side panel sheet placed.</li> </ul> <p><b>Current Status:</b><br/><b>Satisfactory</b></p> | <p>No further action is required against this observation.</p> | |

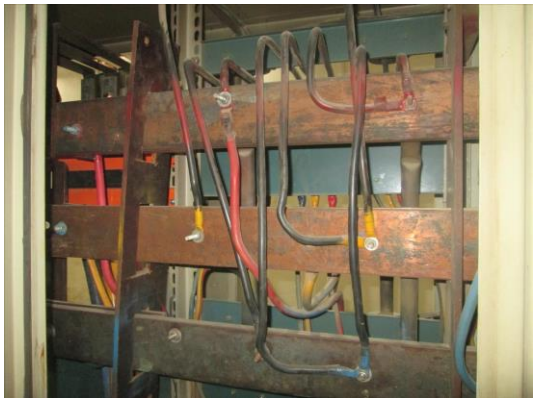
| BV Observation | | |
|---|---|---|
| <ul style="list-style-type: none"> <li>Standard color of bus bars for three phase's indication not followed.</li> </ul> | <ul style="list-style-type: none"> <li>Standard colored bus bars (Red/Yellow/Blue) for three phase's indication shall be followed.</li> </ul> | |

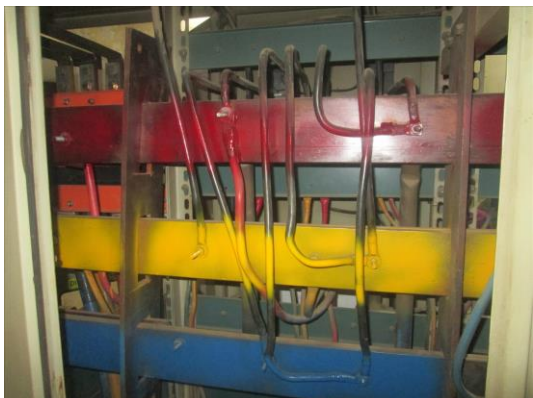
| BV Observation | | |
|---|---|---|
| <ul style="list-style-type: none"> <li>Standard color coding (Red/Yellow/Blue) for three phase's indication followed on bus bars.</li> </ul> <p><b>Current Status:</b><br/><b>Satisfactory</b></p> | <p>No further action is required against this observation.</p> | |

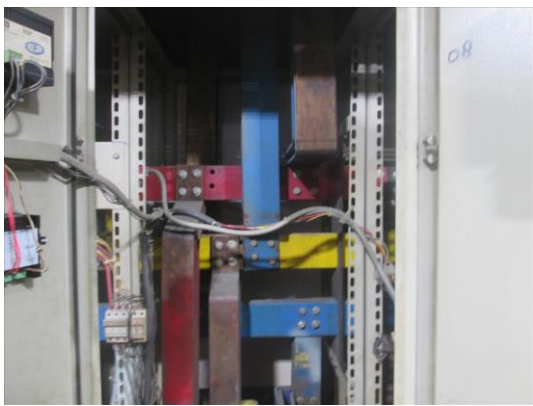
| BV Observation | | |
|---|---|---|
| <ul style="list-style-type: none"> <li>Standard color of bus bars for three phase's indication not followed.</li> </ul> | <ul style="list-style-type: none"> <li>Standard colored bus bars (Red/Yellow/Blue) for three phase's indication shall be followed.</li> </ul> | |

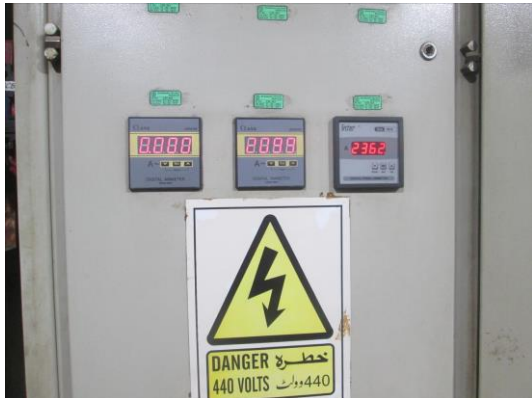
| BV Observation | | |
|---|---|---|
| <ul style="list-style-type: none"> <li>Faulty ampere meters used.</li> </ul> | <ul style="list-style-type: none"> <li>Meters to calculate ampere &amp; voltages shall be accurate &amp; calibrated.</li> </ul> | |

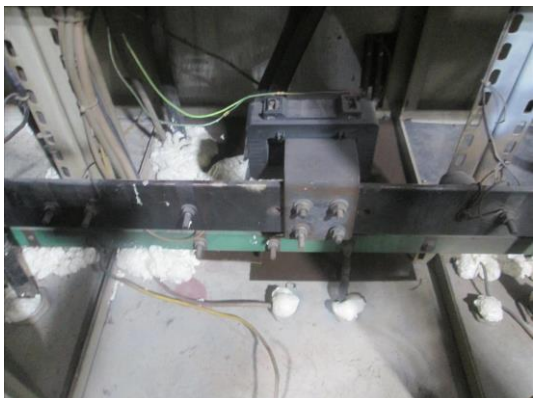
| BV Observation | | |
|---|---|---|
| <ul style="list-style-type: none"> <li>Bottom side panel sheet placed &amp; Opening cover with fire retardant foaming material.</li> </ul> <p><b><u>Current Status:</u></b><br/><b>Satisfactory</b></p> | <p>No further action is required against this observation.</p> | |

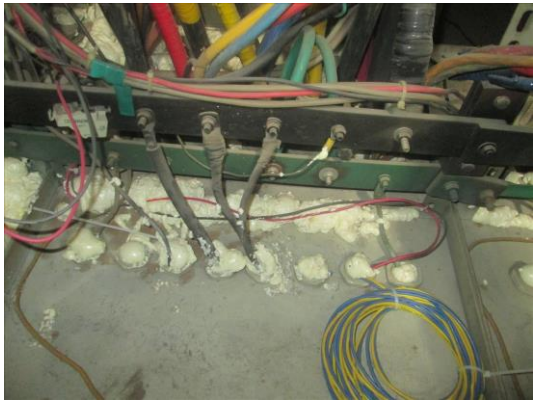
**8. LT Room – Electrical Panel No. 12 (Outgoing)**

| BV Observation | | |
|---|---|---|
| <ul style="list-style-type: none"> <li>Bottom side of the panel is sealed from foam.</li> </ul> <p><b>Current Status:</b><br/><b>Satisfactory</b></p> | <p>No further action is required against this observation.</p> | |

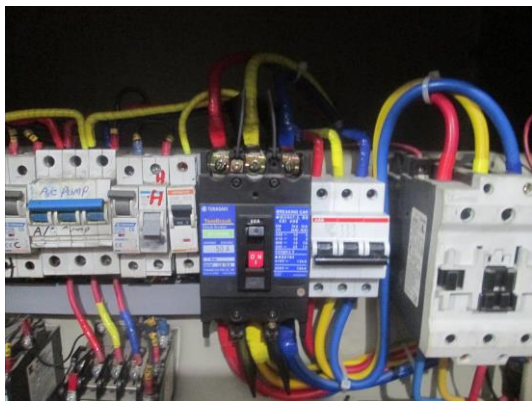
| BV Observation | | |
|---|---|---|
| <ul style="list-style-type: none"> <li>Phase separators of MCCBs provided &amp; looping removed.</li> </ul> <p><b>Current Status:</b><br/><b>Satisfactory</b></p> | <p>No further action is required against this observation.</p> | |

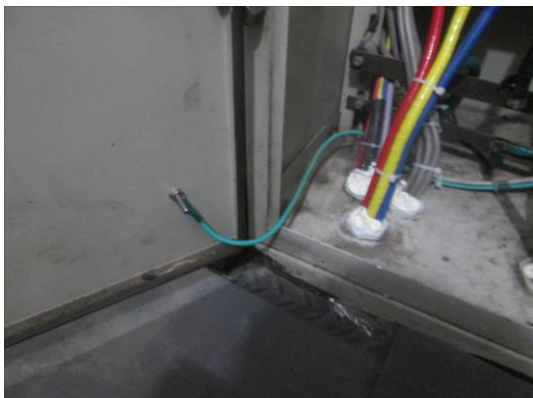
| BV Observation | | |
|---|---|---|
| <ul style="list-style-type: none"> <li>E.C.C. connected with the panel's door.</li> </ul> <p><b>Current Status:</b><br/><b>Satisfactory</b></p> | <p>No further action is required against this observation.</p> | |

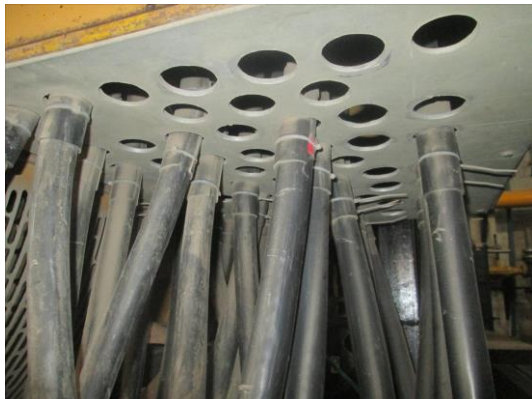
**10. Generator Area – Power House**

| BV Observation | | |
|---|---|---|
| <ul style="list-style-type: none"> <li>Glands not used.</li> </ul> | <ul style="list-style-type: none"> <li>glands of appropriate size shall be provided at the cable's entry / exit points of cables into the panel</li> </ul> | |

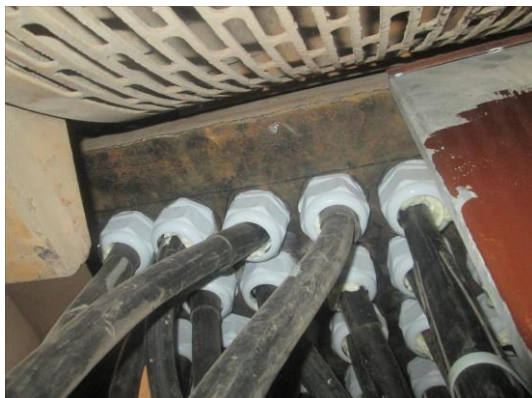
| BV Observation | | |
|---|---|---|
| <ul style="list-style-type: none"> <li>Glands used.</li> </ul> <p><b>Current Status:</b><br/><b>Satisfactory</b></p> | <p>No further action is required against this observation.</p> | |

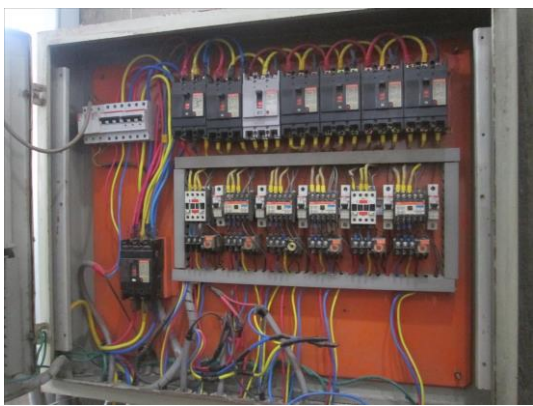
| BV Observation | | |
|---|---|---|
| <ul style="list-style-type: none"> <li>Messy / junky arrangement of cables.</li> <li>Open ended tapped spare cables.</li> </ul> | <ul style="list-style-type: none"> <li>Cables shall be properly harnessed &amp; laced.</li> <li>Open ended spare cables shall be identified or removed.</li> </ul> | |

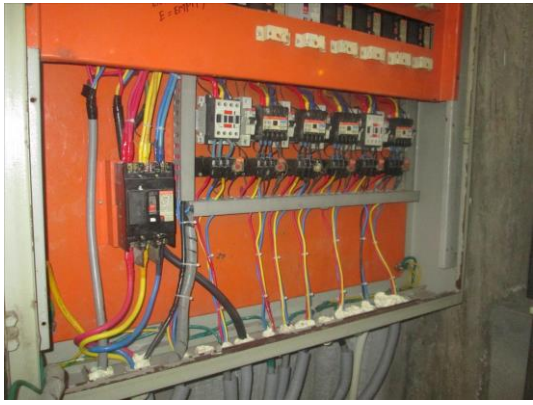
| BV Observation | | |
|---|---|---|
| <ul style="list-style-type: none"> <li>Cable arrangement improved.</li> <li>Open ended spare cables removed.</li> </ul> <p><b>Current Status:</b><br/><b>Satisfactory</b></p> | No further action is required against this observation. | |

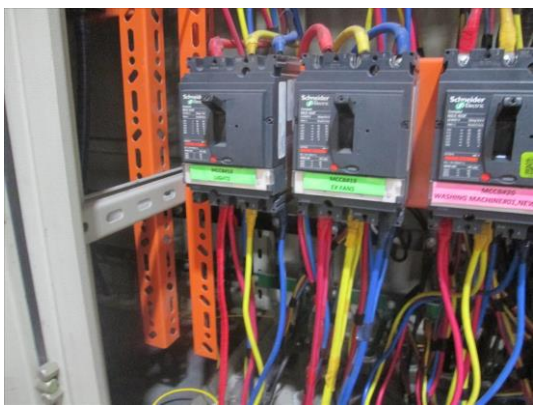
**13. MDB No. 53 – Washing Hall**

| BV Observation | | |
|---|---|---|
| <ul style="list-style-type: none"> <li>Multiple terminations using wires of different gauges.</li> </ul> | <ul style="list-style-type: none"> <li>Multiple terminations shall be removed – every load shall be connected using independent &amp; appropriate rating circuit breaker(s). This action applies to all locations with similar observation(s).</li> </ul> | |

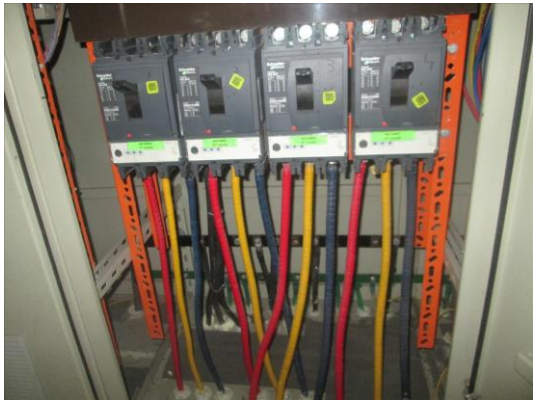
| BV Observation | | |
|---|---|---|
| <ul style="list-style-type: none"> <li>Multiple termination removed.</li> </ul> <p><b>Current Status:</b><br/><b>Satisfactory</b></p> | <p>No further action is required against this observation.</p> | |

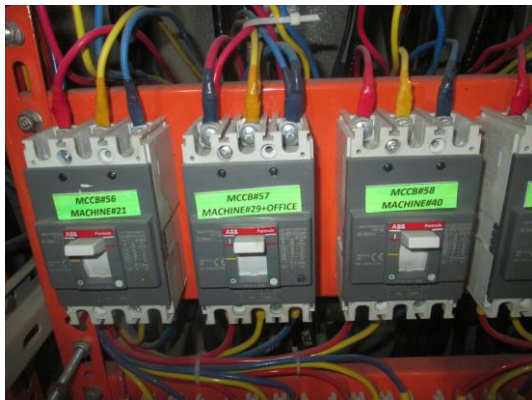
**14. MDB No. 16 – Knitting Hall**

| BV Observation | | |
|---|---|---|
| <ul style="list-style-type: none"> <li>Multiple terminations using wires of different gauges.</li> </ul> | <ul style="list-style-type: none"> <li>Multiple terminations shall be removed – every load shall be connected using independent &amp; appropriate rating circuit breaker(s). This action applies to all locations with similar observation(s).</li> </ul> | |

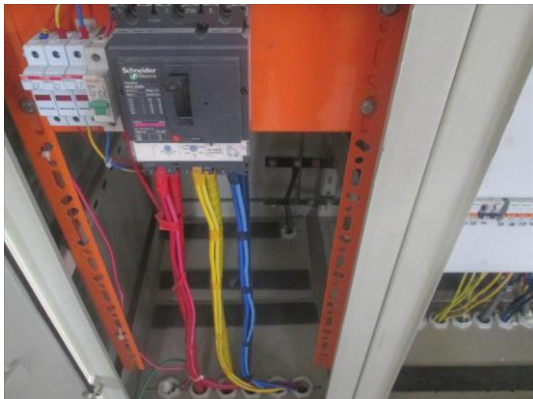
| BV Observation | | |
|---|---|---|
| <ul style="list-style-type: none"> <li>Multiple terminations using wires of different gauges.</li> </ul> | <ul style="list-style-type: none"> <li>Multiple terminations shall be removed – every load shall be connected using independent &amp; appropriate rating circuit breaker(s). This action applies to all locations with similar observation(s).</li> </ul> | |

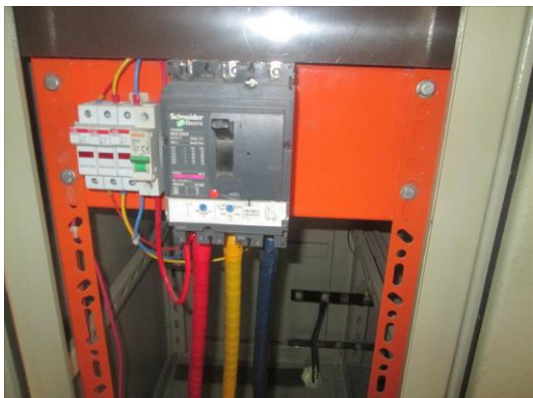
| BV Observation | | |
|---|---|---|
| <ul style="list-style-type: none"> <li>Multiple termination removed.</li> </ul> <p><b>Current Status:</b><br/><b>Satisfactory</b></p> | <p>No further action is required against this observation.</p> | |

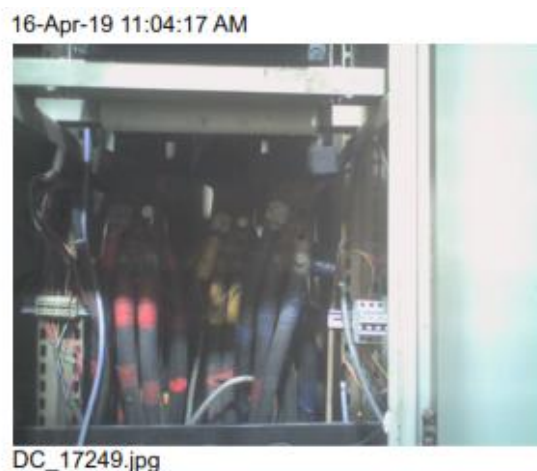
**Equipment ID or Name: LT Room – Generator Incoming**

No thermal abnormality found.

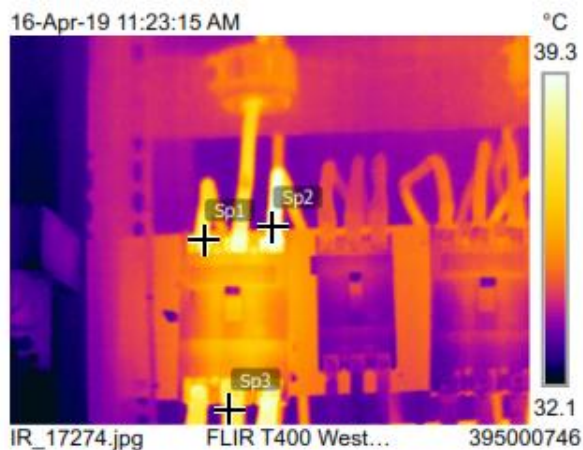
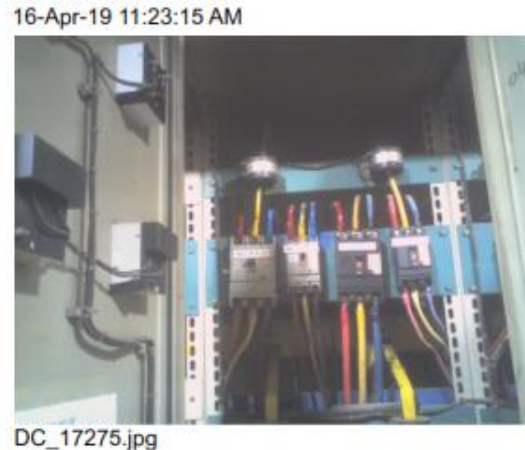
**Equipment ID or Name: LT Room – Electrical Panel # 09 (Outgoing)**

No thermal abnormality found.

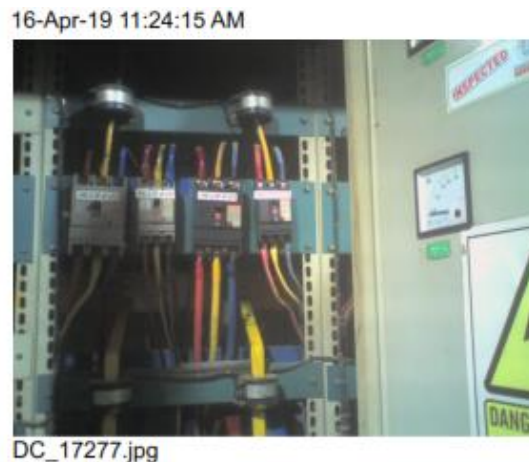
**Equipment ID or Name: LT Room – Electrical Panel # 03 (Outgoing)**

| Sr.No | Observations & Recommendations | | |
|---|---|---|---|
| 2 | Outgoing P-03<br>LT Room | Low grade temperature raise found, load unbalance/loose connection to be Monitored | 17276 & Page-06 |

| Measurement Point | Temperature °C | Remarks |
|---|---|---|
| Spot 3 | 44.4 | Probable Deficiency |

Thermal abnormality found.

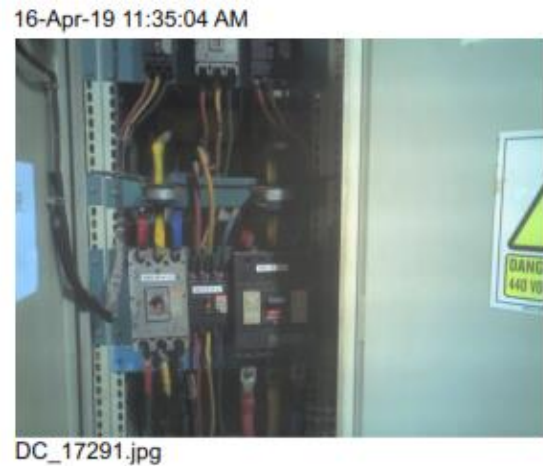
**Equipment ID or Name: LT Room – Electrical Panel # 04 (Outgoing)**

No thermal abnormality found.

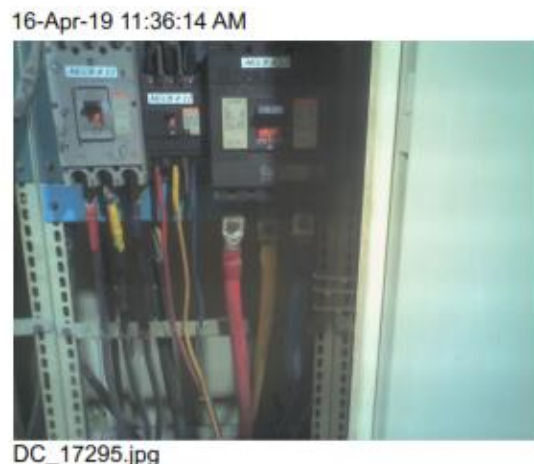
**Equipment ID or Name: LT Room – Electrical Panel # 04 (Outgoing)**

No thermal abnormality found.

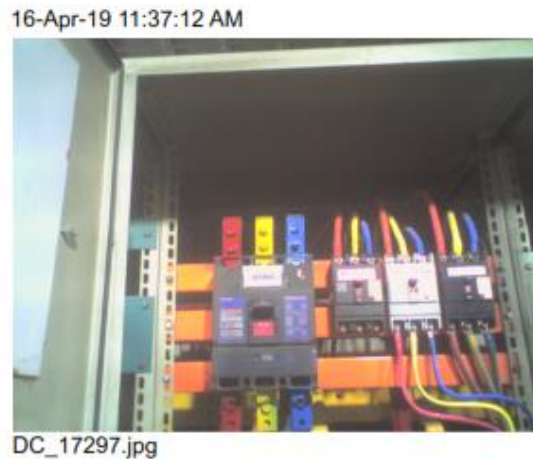
**Equipment ID or Name: LT Room – Electrical Panel # 05 (Outgoing)**

No thermal abnormality found.

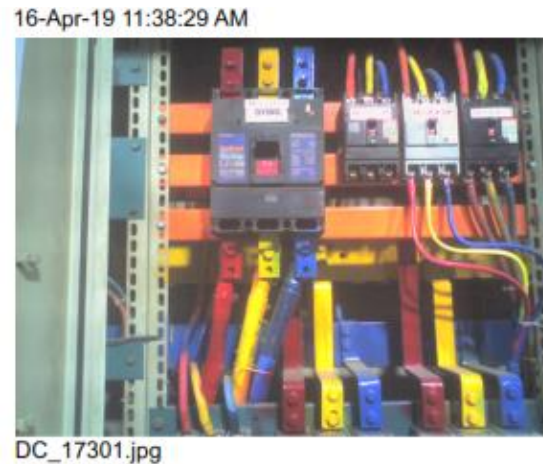
**Equipment ID or Name: LT Room – Electrical Panel # 05 (Outgoing)**

| Measurement Point | Temperature °C | Remarks |
|---|---|---|
| Spot 2 | 42.4 | Probable Deficiency |

Thermal abnormality found.

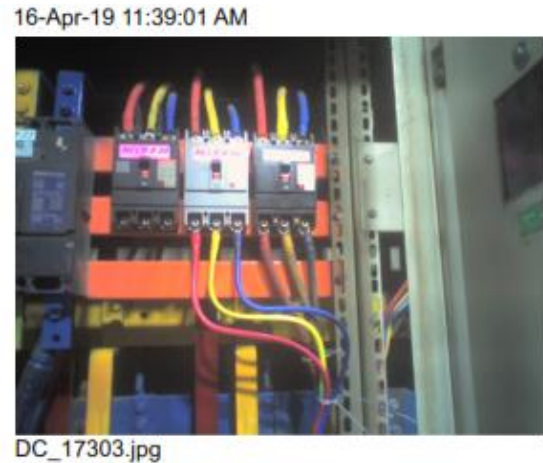
**Equipment ID or Name: LT Room – Electrical Panel # 05 (Outgoing)**

| Measurement Point | Temperature °C | Remarks |
|---|---|---|
| Spot 1 | 43.0 | Probable Deficiency |
| Spot 2 | 40.8 | Probable Deficiency |

Thermal abnormality found.

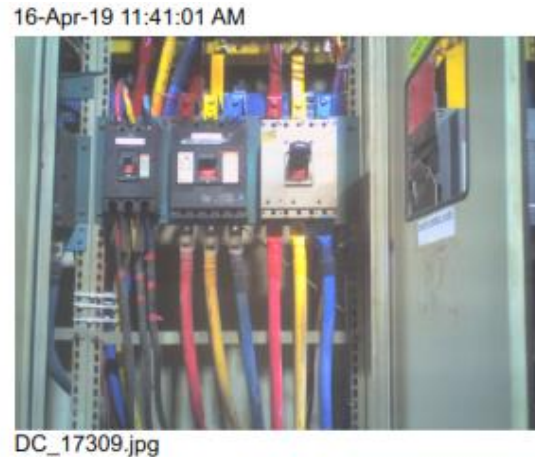
**Equipment ID or Name: LT Room – Electrical Panel # 05 (Outgoing)**

| Measurement Point | Temperature °C | Remarks |
|---|---|---|
| Spot 1 | 50.7 | Certain Deficiency |
| Spot 2 | 40.8 | Probable Deficiency |

Thermal abnormality found.

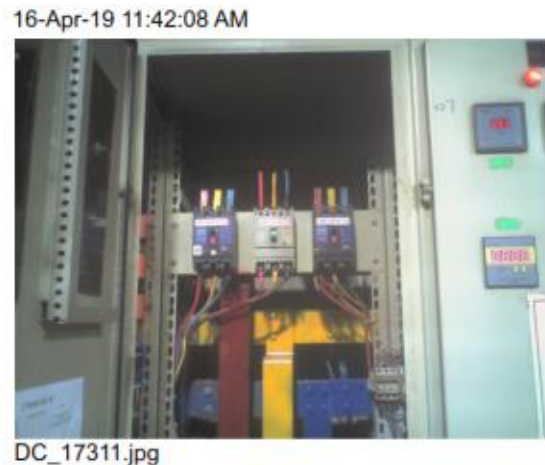
**Equipment ID or Name: LT Room – Electrical Panel # 06 (Outgoing)**

No thermal abnormality found.

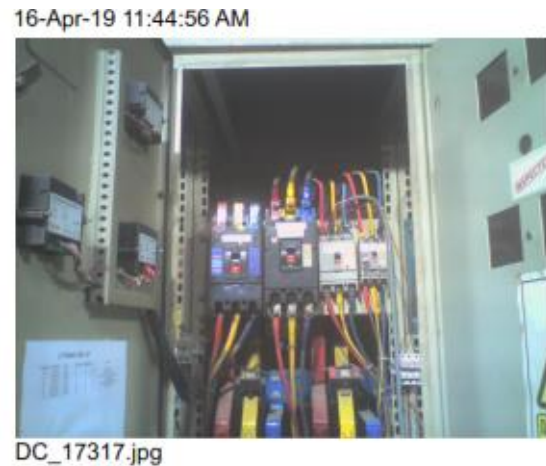
**Equipment ID or Name: LT Room – Electrical Panel # 10 (Outgoing)**

| Sr.No | Observations & Recommendations | | |
|---|---|---|---|
| 5 | Outgoing P-10<br>LT Room | Low grade temperature raise found, load unbalance/loose connection to be Monitored | 17316 & Page-17 |

| Measurement Point | Temperature °C | Remarks |
|---|---|---|
| Spot 1 | 42.1 | Probable Deficiency |
| Spot 2 | 42.6 | Probable Deficiency |
| Spot 3 | 43.4 | Probable Deficiency |

Thermal abnormality found.

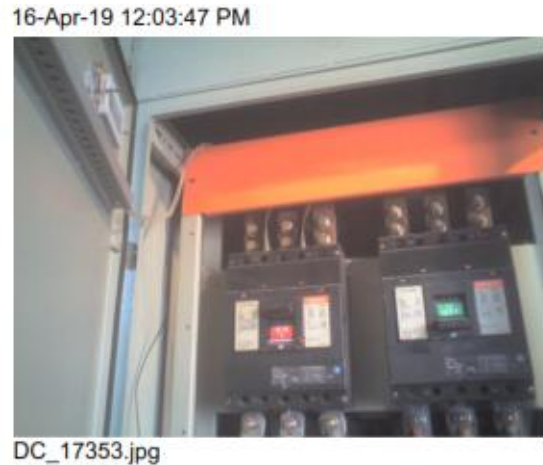
**Equipment ID or Name: LT Room – Electrical Panel # 17 (Outgoing)**

| Measurement Point | Temperature °C | Remarks |
|---|---|---|
| Spot 1 | 54.3 | Certain Deficiency |
| Spot 2 | 44.4 | Probable Deficiency |

Thermal abnormality found.

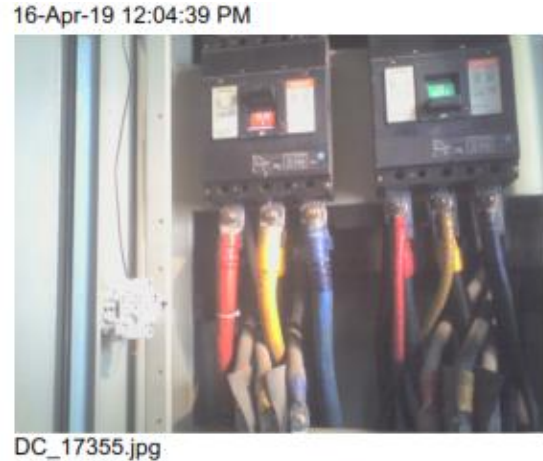
**Equipment ID or Name: LT Room – Electrical Panel # 17 (Outgoing)**

| Measurement Point | Temperature °C | Remarks |
|---|---|---|
| Spot 1 | 43.7 | Probable Deficiency |
| Spot 2 | 42.3 | Probable Deficiency |

Thermal abnormality found.

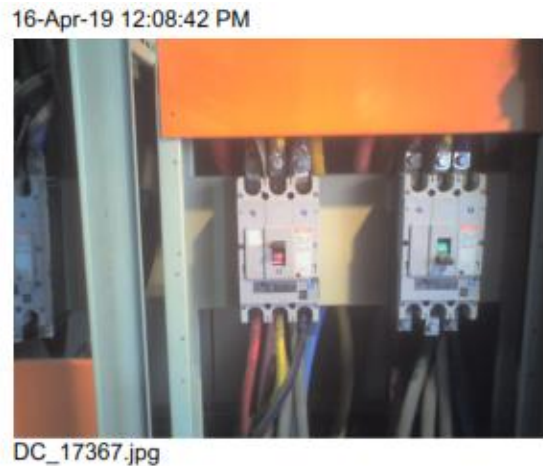
**Equipment ID or Name: LT Room – Electrical Panel # 18 (Outgoing)**

No thermal abnormality found.

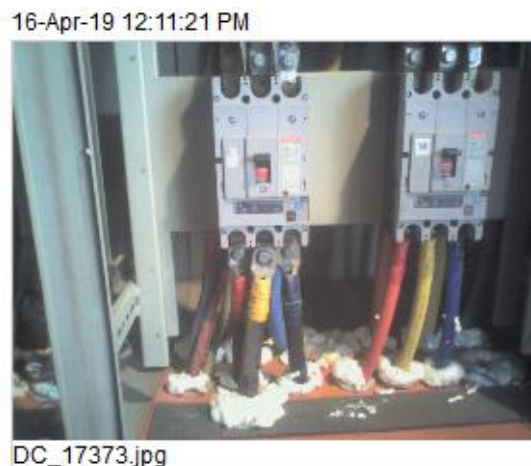
**Equipment ID or Name: LT Room – Electrical Panel # 18 (Outgoing)**

| Measurement Point | Temperature °C | Remarks |
|---|---|---|
| Spot 1 | 44.7 | Probable Deficiency |
| Spot 2 | 50.4 | Certain Deficiency |

Thermal abnormality found.

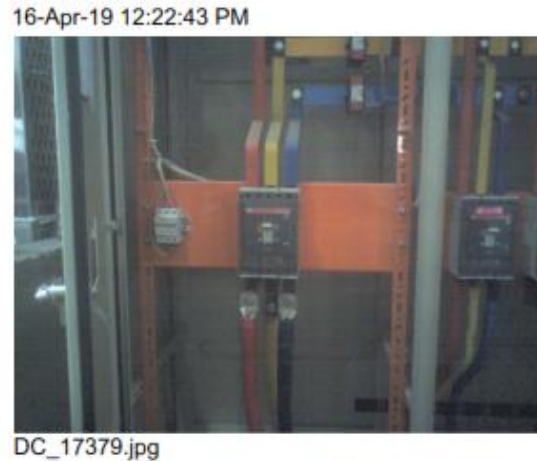
**Equipment ID or Name:**                      **Main Distribution Panel # 35**

No thermal abnormality found.

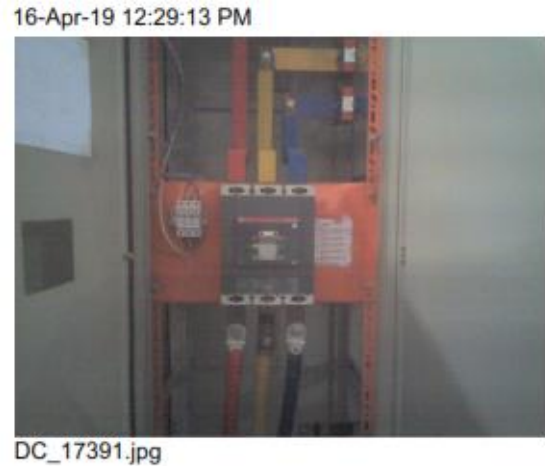
**Equipment ID or Name:**                      **Main Distribution Panel # 36**

No thermal abnormality found.

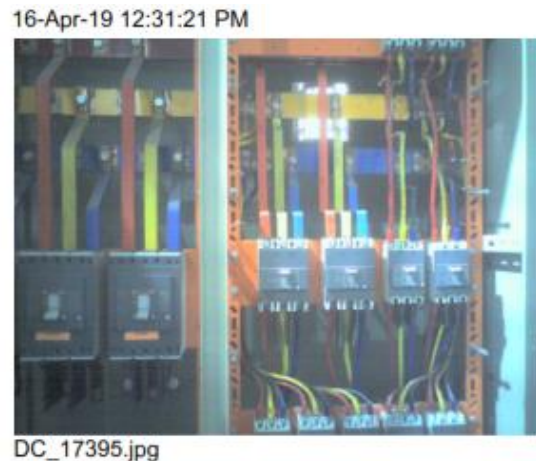
**Equipment ID or Name:**                      **Main Distribution Panel # 36**

No thermal abnormality found.

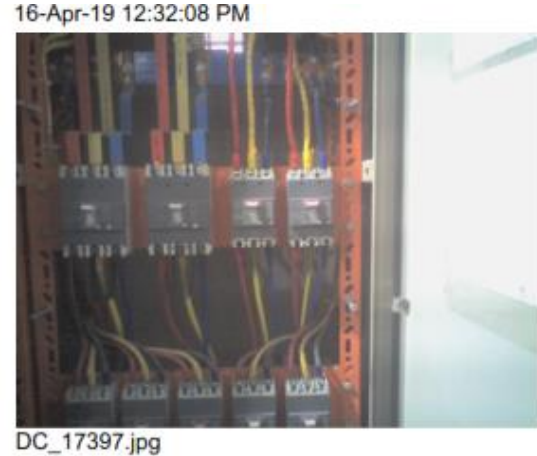
**Equipment ID or Name:** Main Distribution Panel # 36

No thermal abnormality found.

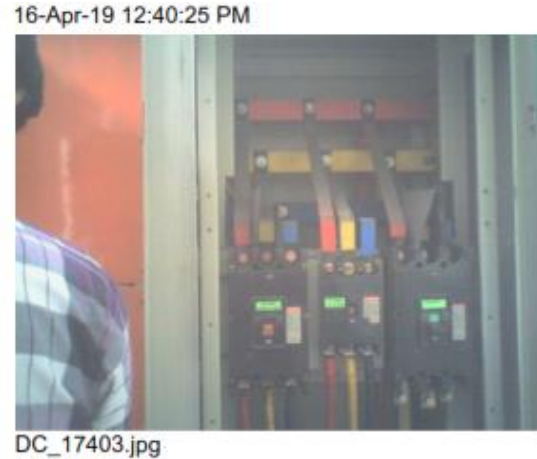
**Equipment ID or Name:**                      **Main Distribution Panel # 52**

| Measurement Point | Temperature °C | Remarks |
|---|---|---|
| Spot 2 | 49.9 | Probable Deficiency |

Thermal abnormality found.

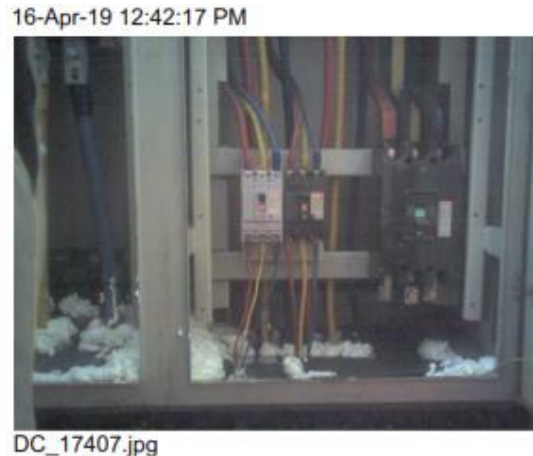
**Equipment ID or Name:**                      **Main Distribution Panel # 52**

No thermal abnormality found.

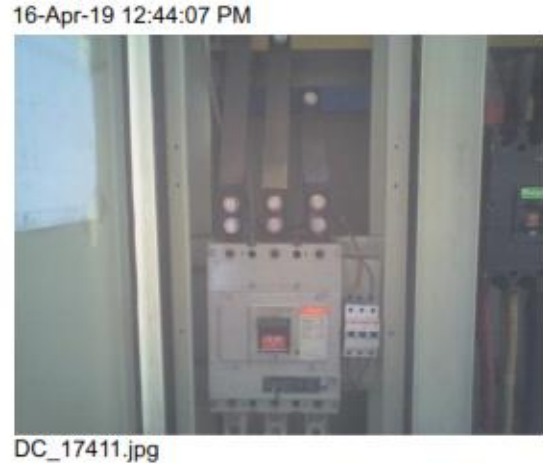
**Equipment ID or Name:**                      **Main Distribution Panel # 52**

No thermal abnormality found.

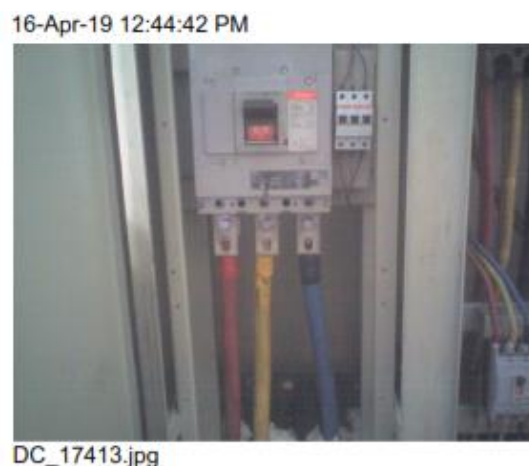
**Equipment ID or Name:**                      **Main Distribution Panel # 52**

No thermal abnormality found.

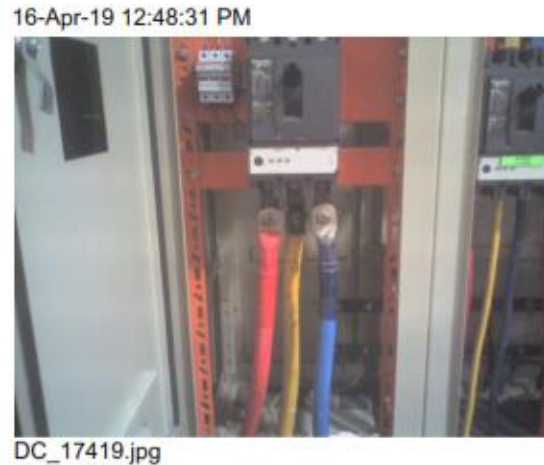
**Equipment ID or Name:**                      **Main Distribution Panel # 53**

No thermal abnormality found.

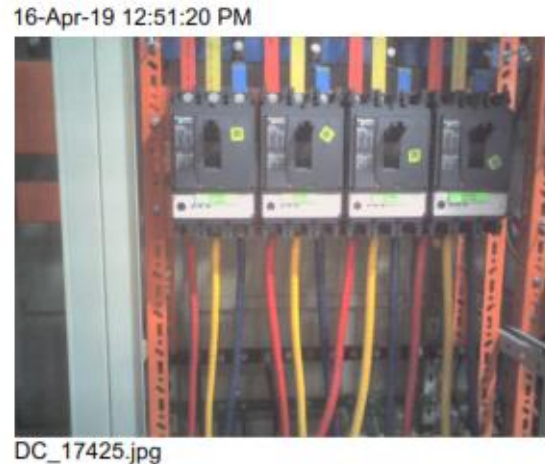
**Equipment ID or Name:**                      **Main Distribution Panel # 53**

No thermal abnormality found.

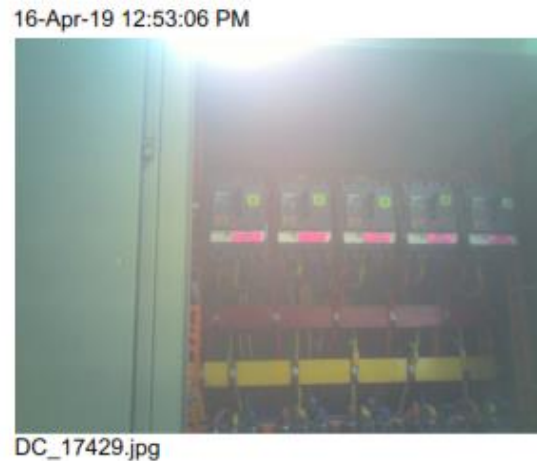
**Equipment ID or Name:**                      **Main Distribution Panel # 53**

| Measurement Point | Temperature °C | Remarks |
|---|---|---|
| Spot 1 | 41.2 | Probable Deficiency |
| Spot 2 | 41.0 | Probable Deficiency |

Thermal abnormality found.

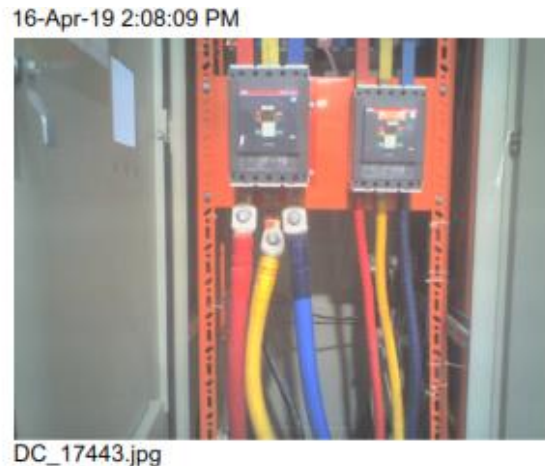
**Equipment ID or Name:**                      **Main Distribution Panel # 16**

No thermal abnormality found.

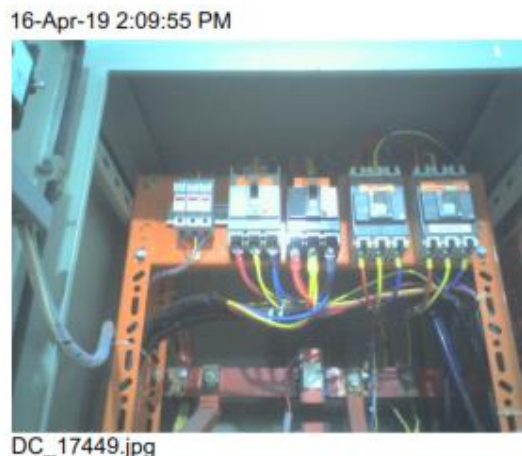
**Equipment ID or Name:**                      **Main Distribution Panel # 16**

No thermal abnormality found.

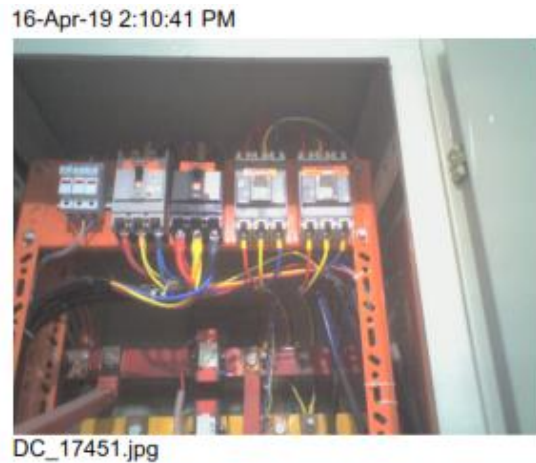
**Equipment ID or Name:**                      **Main Distribution Panel # 16**

| Measurement Point | Temperature °C | Remarks |
|---|---|---|
| Spot 2 | 43.3 | Probable Deficiency |

Thermal abnormality found.

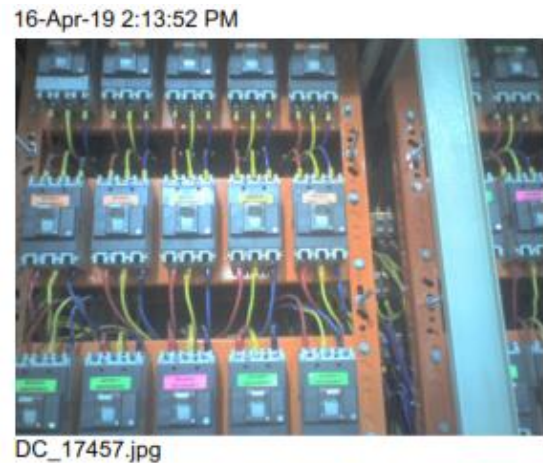
**Equipment ID or Name:**                      **Main Distribution Panel # 16**

No thermal abnormality found.

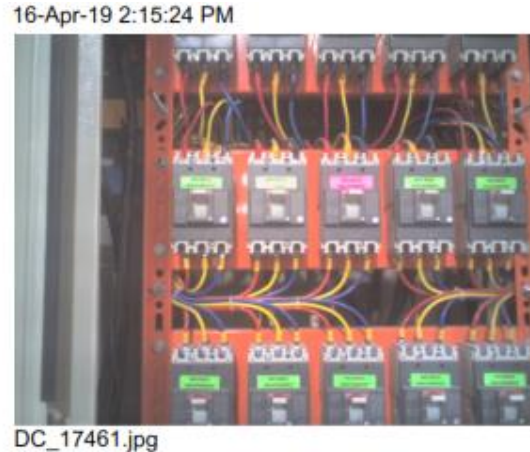
**Equipment ID or Name:**                      **Main Distribution Panel # 16**

No thermal abnormality found.

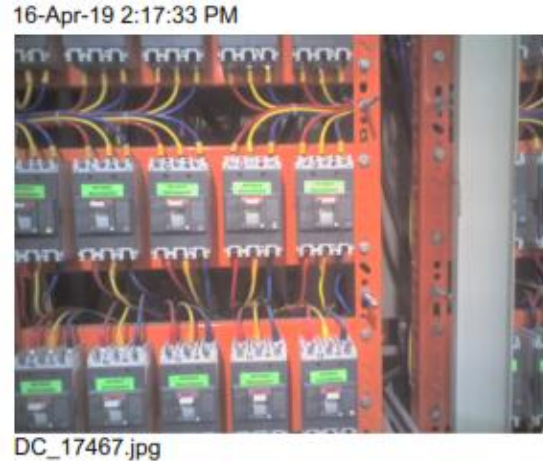
**Equipment ID or Name:**                      **Main Distribution Panel # 16**

No thermal abnormality found.

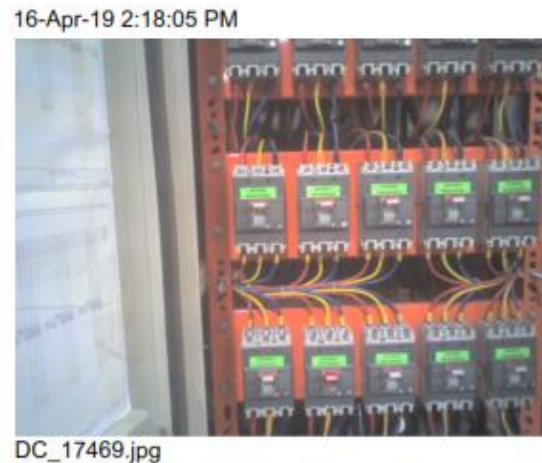
**Equipment ID or Name:**                      **Main Distribution Panel # 16**

No thermal abnormality found.

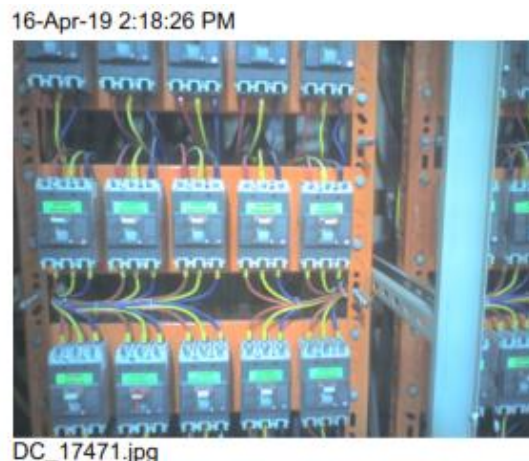
**Equipment ID or Name:**                      **Main Distribution Panel # 16**

No thermal abnormality found.

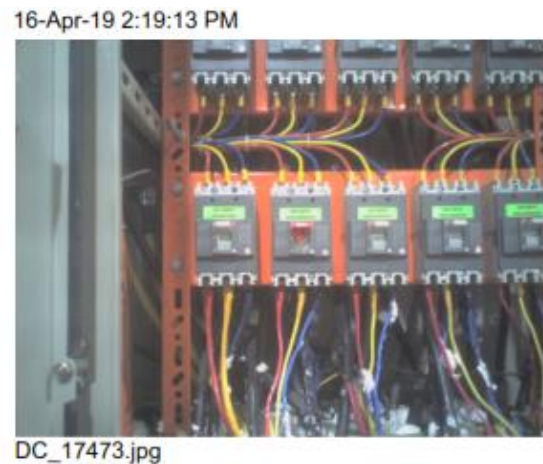
**Equipment ID or Name:**                      **Main Distribution Panel # 16**

No thermal abnormality found.

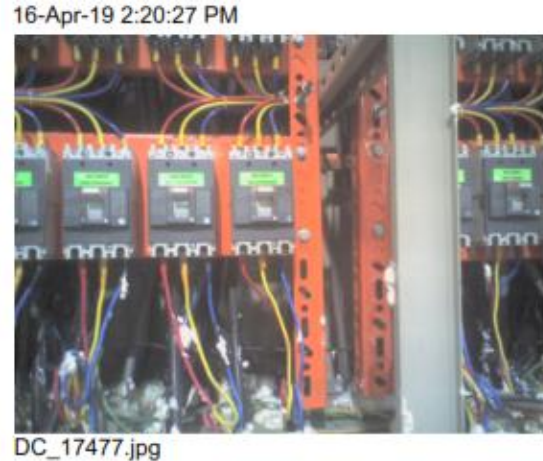
**Equipment ID or Name:**                      **Main Distribution Panel # 16**

No thermal abnormality found.

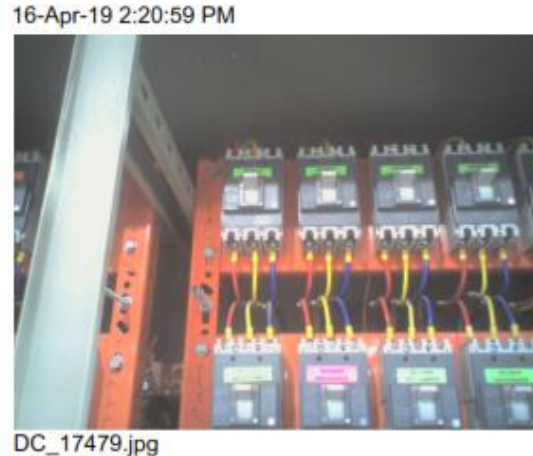
**Equipment ID or Name:**                      **Main Distribution Panel # 16**

No thermal abnormality found.

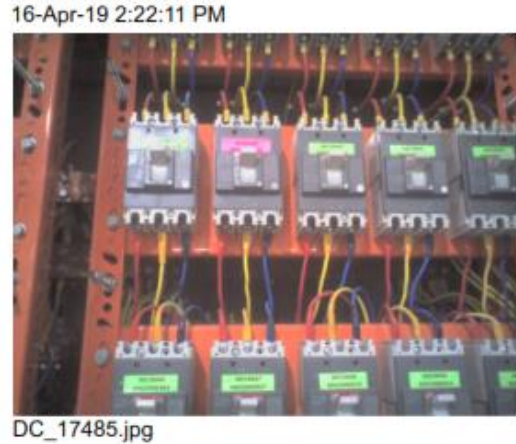
**Equipment ID or Name:**                      **Main Distribution Panel # 16**

No thermal abnormality found.

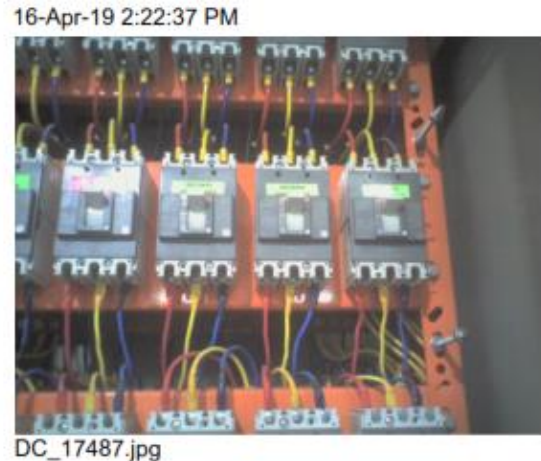
**Equipment ID or Name:**                      **Main Distribution Panel # 16**

No thermal abnormality found.

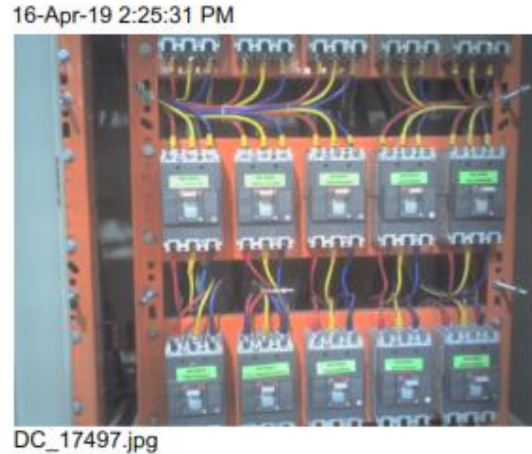
**Equipment ID or Name:**                      **Main Distribution Panel # 16**

No thermal abnormality found.

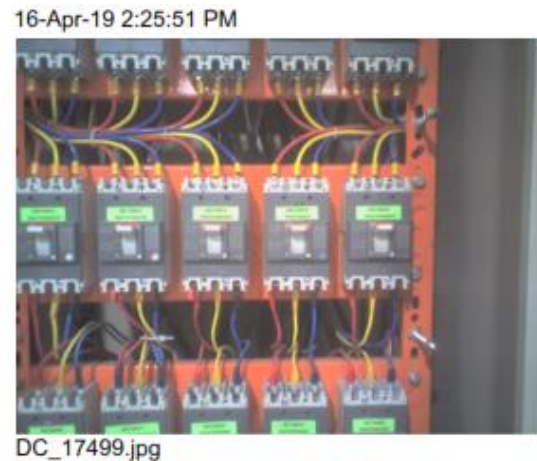
**Equipment ID or Name:** **Main Distribution Panel # 16**

No thermal abnormality found.

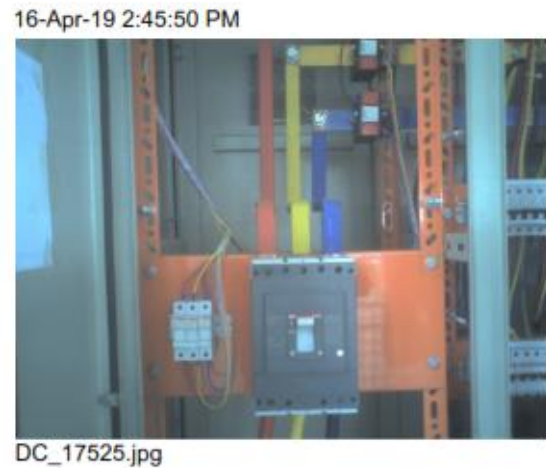
**Equipment ID or Name:** DB – 56.07

No thermal abnormality found.

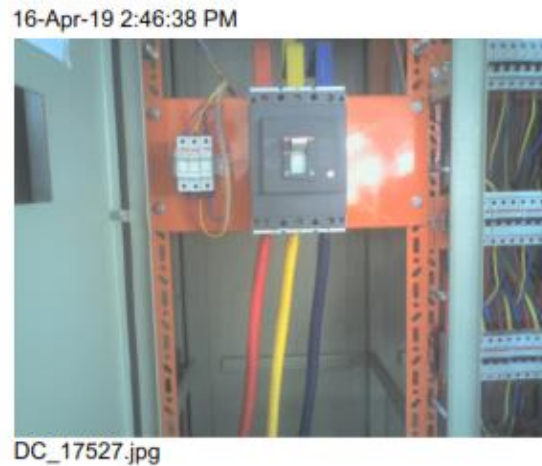
**Equipment ID or Name:** DB – 56.07

No thermal abnormality found.

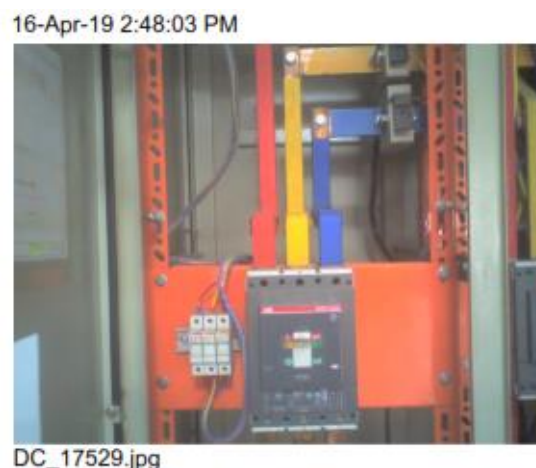
**Equipment ID or Name:**                      **Main Distribution Panel # 56**

| Measurement Point | Temperature °C | Remarks |
|---|---|---|
| Spot 1 | 41.5 | Probable Deficiency |

Thermal abnormality found.

| Sr.No | Observations & Recommendations | | |
|---|---|---|---|
| 13 | MDP-56<br>Hanger Units | Low grade temperature raise found, load unbalance/loose connection to be Monitored | 17528 & Page-65 |

**Probable Deficiency:** Investigate, monitor and take action as necessary – If difference is more than 11 degrees and up to 18 degrees from measured 'Ambient Temperature'.

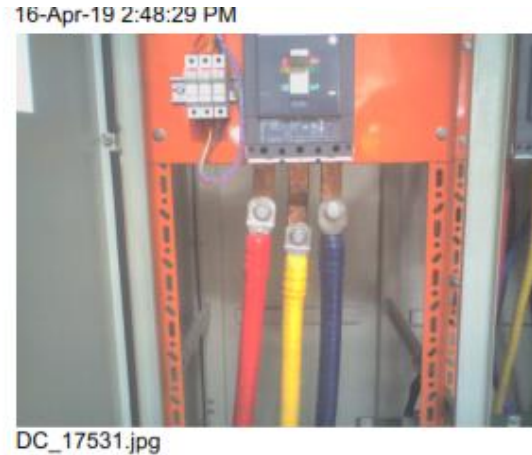
**Equipment ID or Name:**                      **Main Distribution Panel # 56**

No thermal abnormality found.

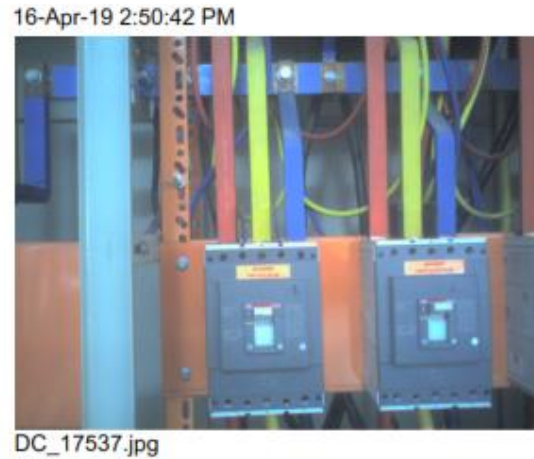
**Equipment ID or Name:**                      **Main Distribution Panel # 56**

No thermal abnormality found.

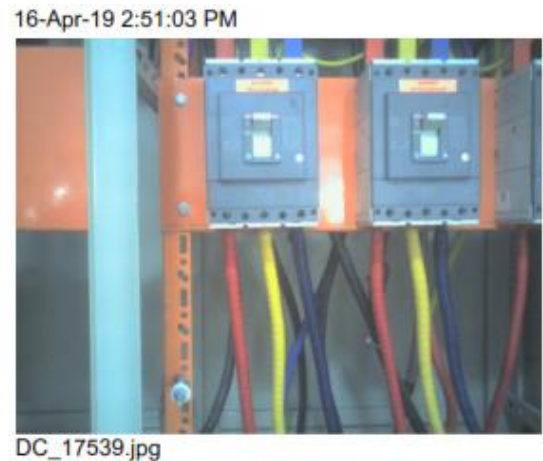
**Equipment ID or Name:**                      **Main Distribution Panel # 56**

No thermal abnormality found.

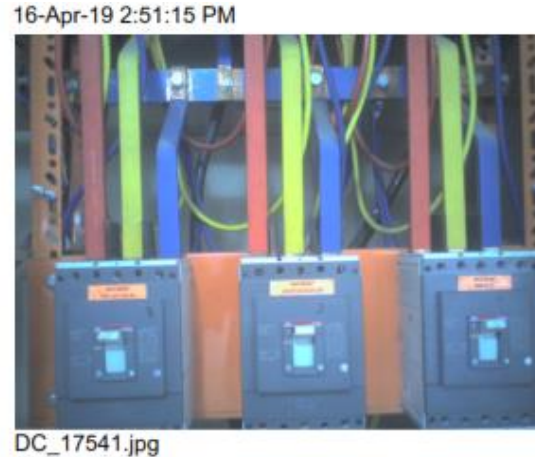
**Equipment ID or Name:**                      **Main Distribution Panel # 56**

No thermal abnormality found.

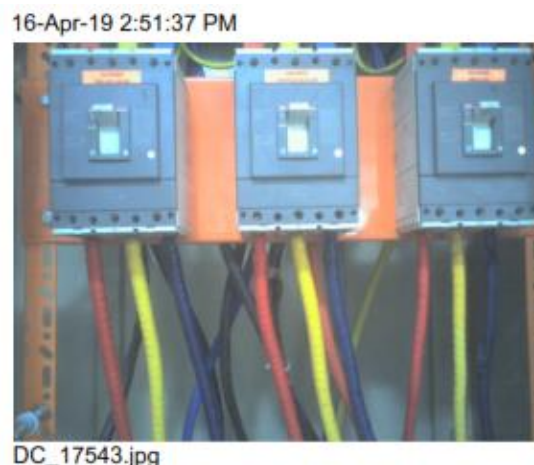
**Equipment ID or Name:**                      **Main Distribution Panel # 56**

No thermal abnormality found.

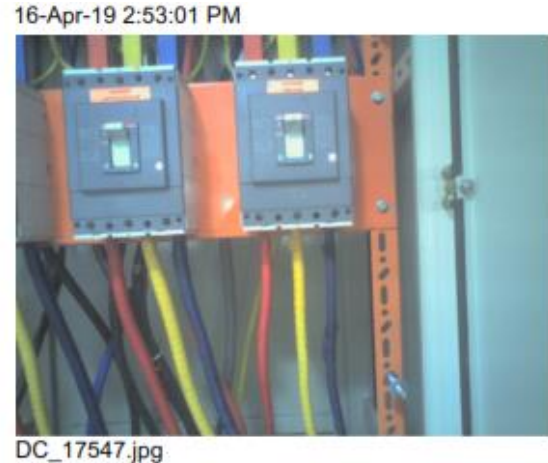
**Equipment ID or Name:** Main Distribution Panel # 56

No thermal abnormality found.

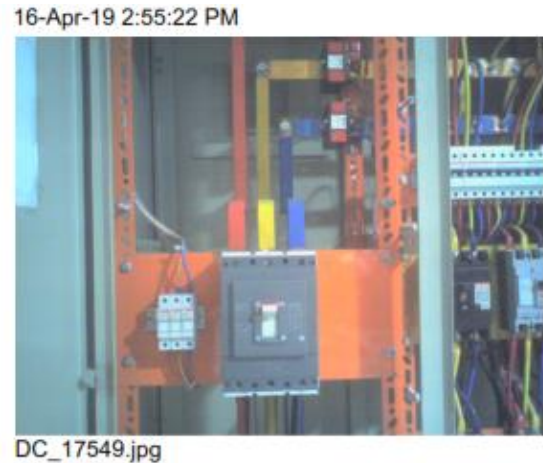
**Equipment ID or Name:** DB – 56.06

No thermal abnormality found.

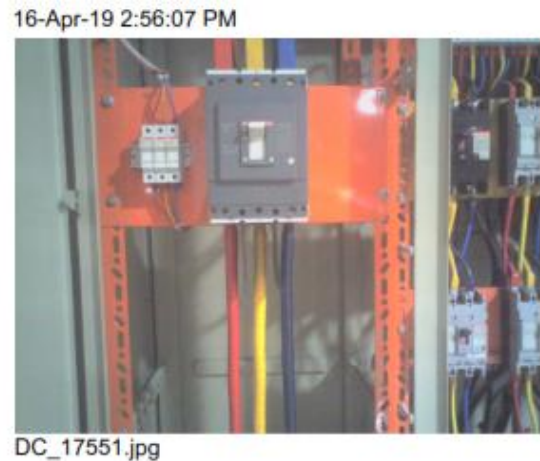
**Equipment ID or Name:** DB – 56.06

No thermal abnormality found.

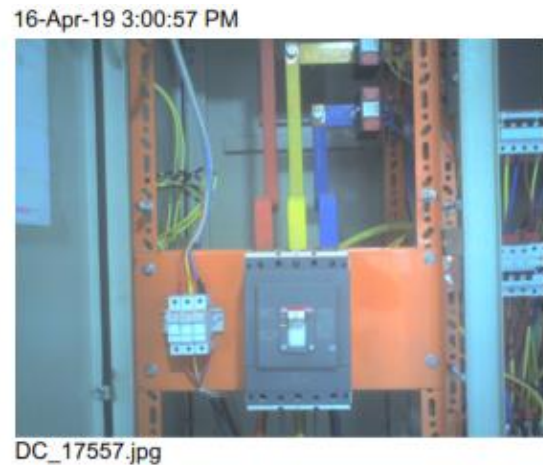
**Equipment ID or Name:** DB – 56.08

No thermal abnormality found.

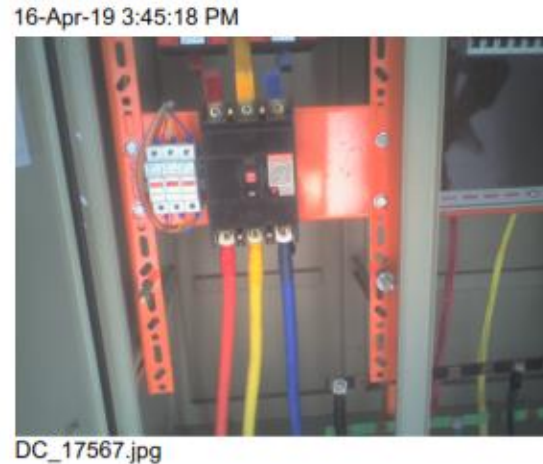
**Equipment ID or Name:** DB – 56.05

No thermal abnormality found.

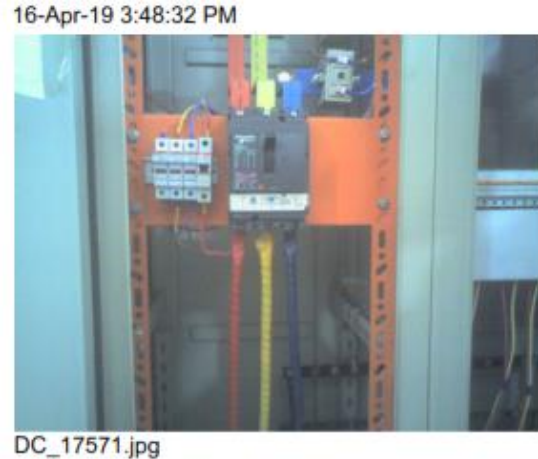
**Equipment ID or Name:** DB – 53.04

No thermal abnormality found.

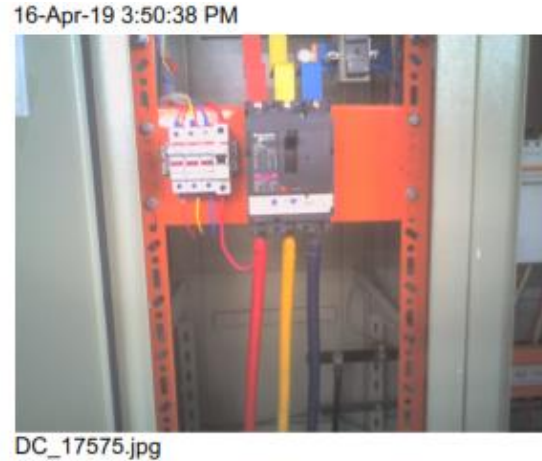
**Equipment ID or Name:** DB – 53.05

No thermal abnormality found.
